MRA Home Inspections

Property Inspection Report

1234 Main St., Parkland Fl., 33076
Inspection prepared for: Sample Report
Inspection Date: 8/16/2010 Time: 10:00AM
Age: 2006 (4years) Size: 3633 sq. ft.
Weather: Clear 92 degrees
Inspection#-0268-10

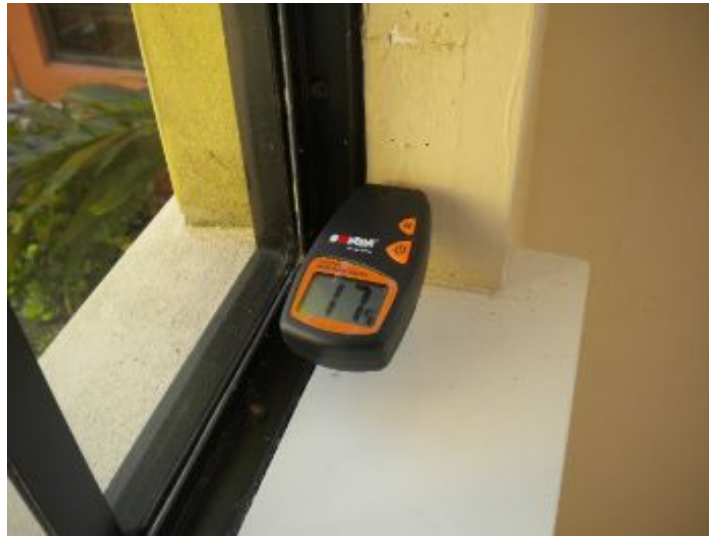
- There is moisture present at the bottom of the stairwell area and in the closet under the stairwell. Recommend having the windows in this area reviewed by a licensed contractor to locate the point of intrusion.
- Estimated cost:\$300-unknown

There is moisture present at the bottom of the stairwell area and in the closet under the stairwell. Recommend having the windows in this area reviewed by a licensed contractor to locate the point of intrusion.

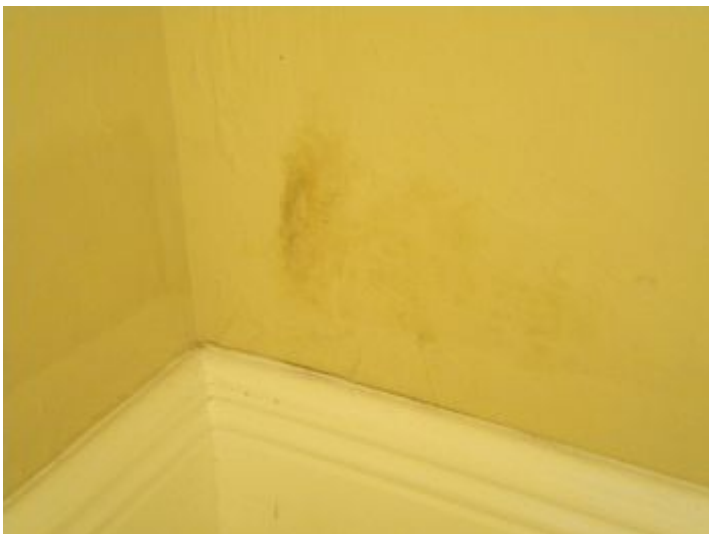
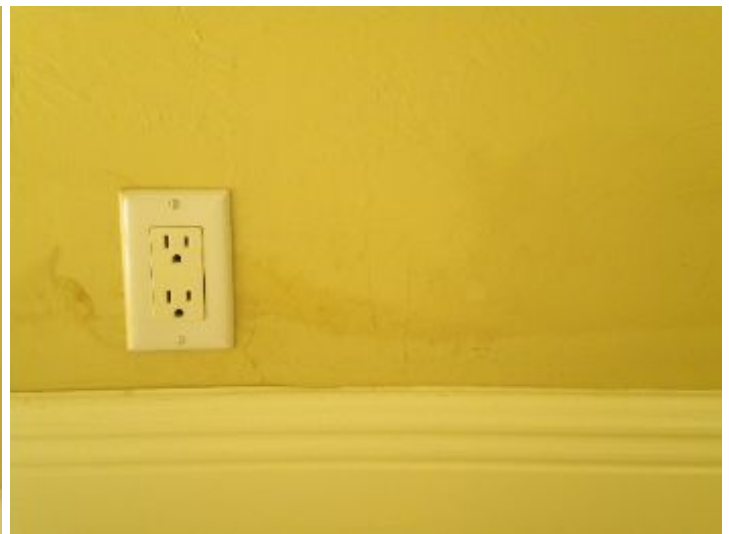
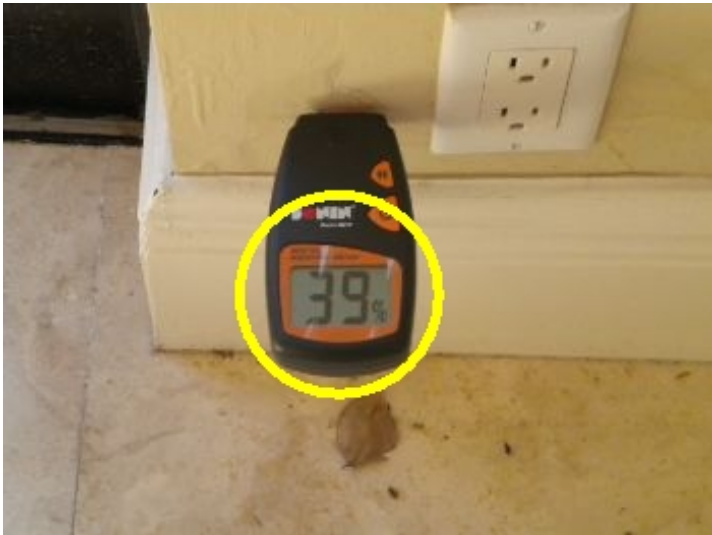
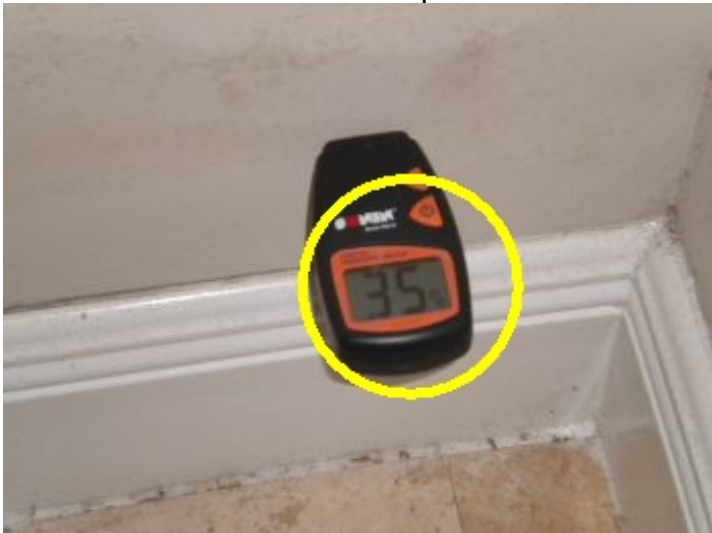
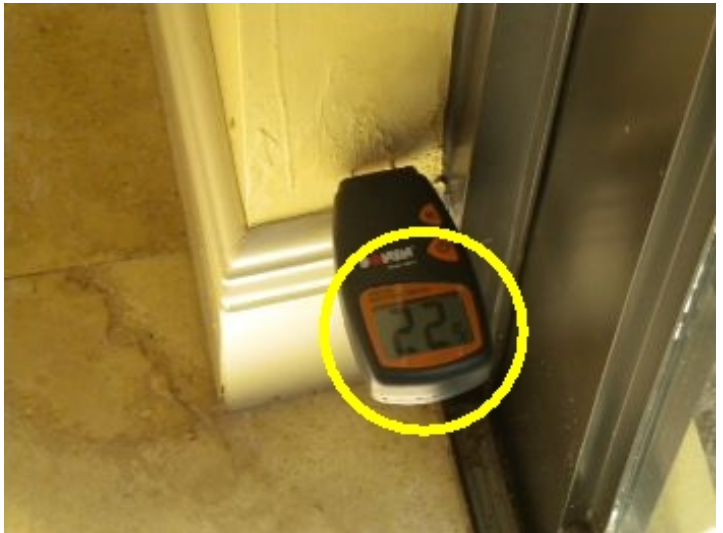
- There is evidence of moisture entering structure at the bottom of the stairwell and inside the closet under the stairwell. Moisture readings were taken and exceed the acceptable level.
- Recommend testing for defective drywall (chinese drywall). See bedroom wall section.

There is evidence of moisture entering structure at the bottom of the stairwell and inside the closet under the stairwell. Moisture readings were taken and exceed the acceptable level.

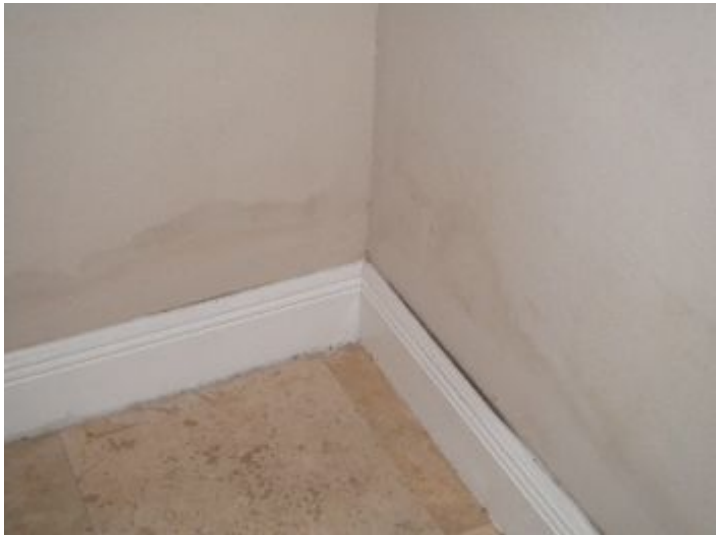
Water stains

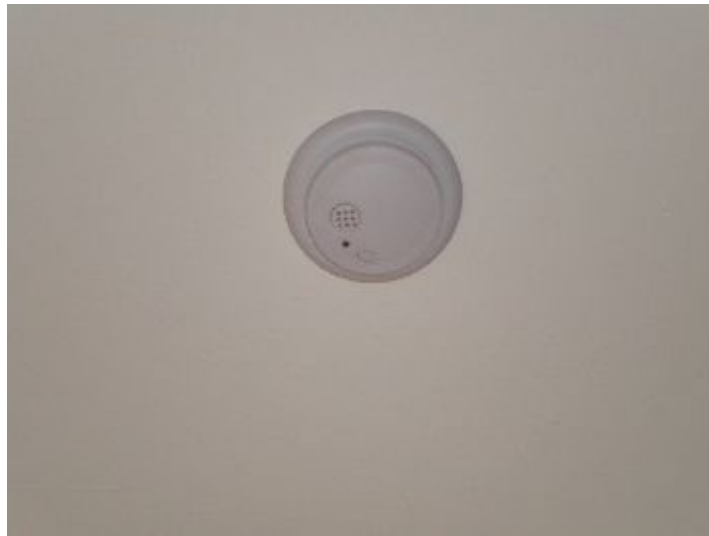
Observations:
 • There are smoke detectors hard wired in and connected to each other, but there was one beeping continually- it may need to be replaced.
 • Estimated cost:
 • \$50-\$100

There are smoke detectors hard wired in and connected to each other, but there was one beeping continually- it may need to be replaced.

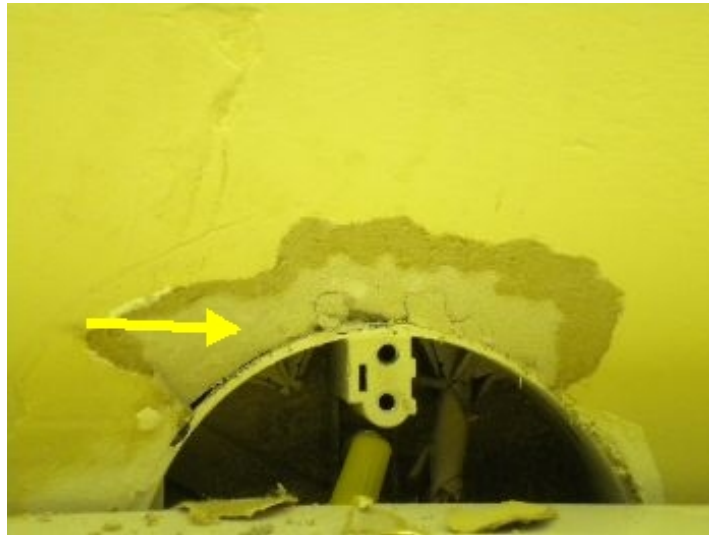
Materials: Drywall walls noted.
 Observations:
 • Defective drywall (Chinese drywall) detected in master bedroom and master closet. Recommend testing of entire house and remediation as required.
 • Estimated cost:\$10,000-unknown

Defective drywall (Chinese drywall) detected in master bedroom and master closet. Recommend testing of entire house and remediation as required.

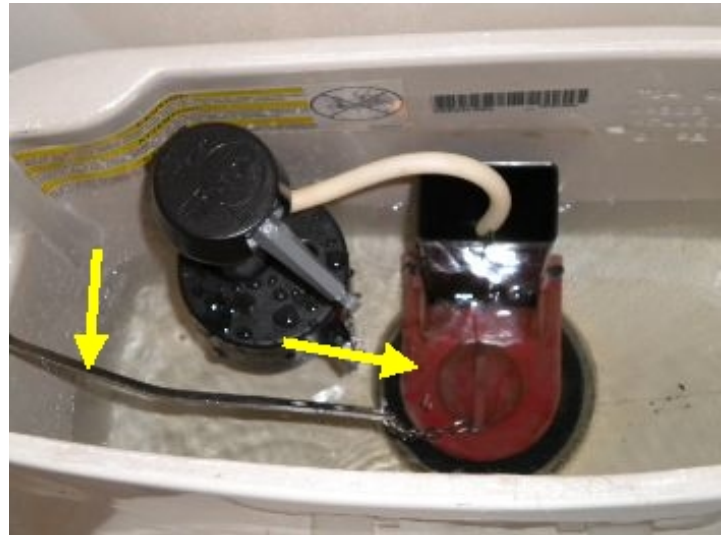
- Mechanism in tank sticking, requires adjustment for proper flushing.
- Estimated cost:\$75

Mechanism in tank sticking, requires adjustment for proper flushing.

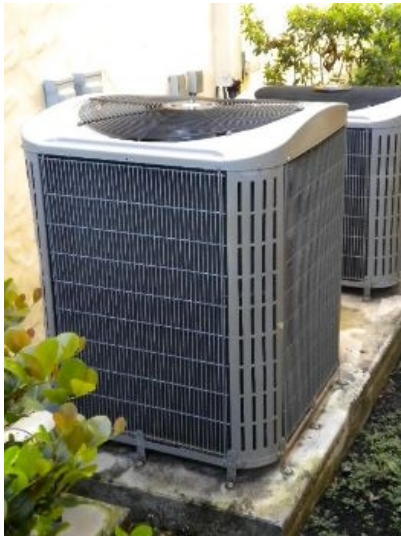
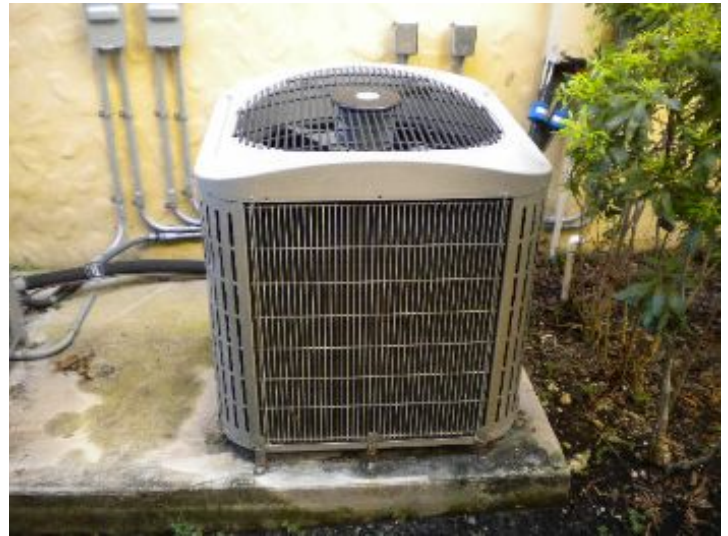
- The air conditioner did not operate properly. Recommend HVAC contractor evaluate the system.
- The typical temperature differential split between supply and return air in an air conditioner of this type is 14 - 22 degrees F. This system achieved an unacceptable differential temperature of 0 degrees F.
- Estimated cost:\$500-unknown

The air conditioner did not operate properly. Recommend HVAC contractor evaluate the system.

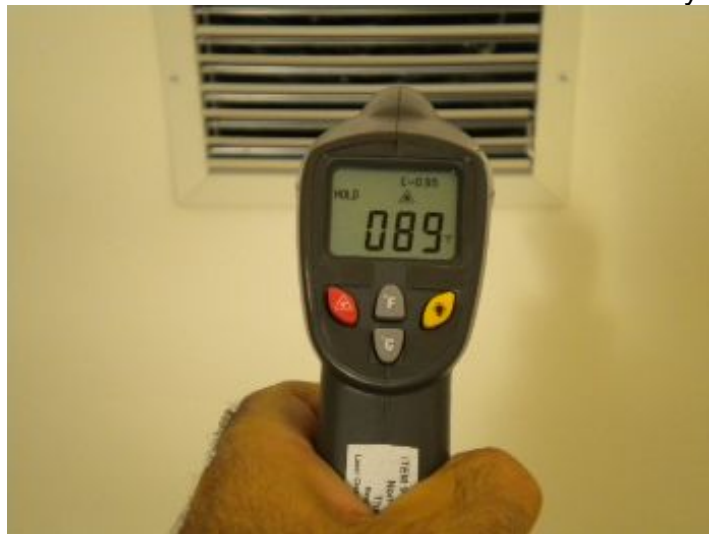
The typical temperature differential split between supply and return air in an air conditioner of this type is 14 - 22 degrees F. This system achieved an unacceptable differential temperature of 0 degrees F.

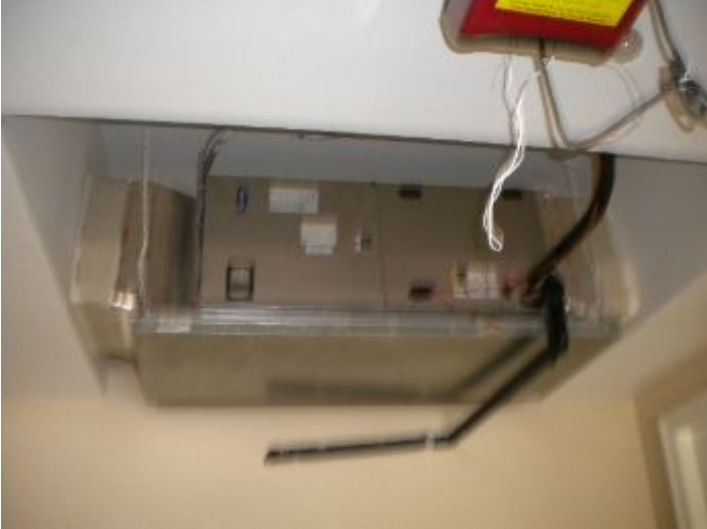
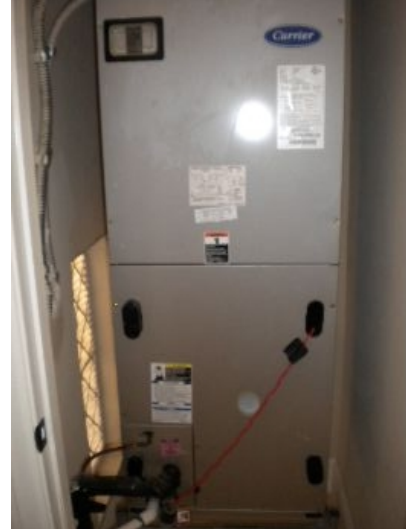
Units did not operate properly at time of inspection.

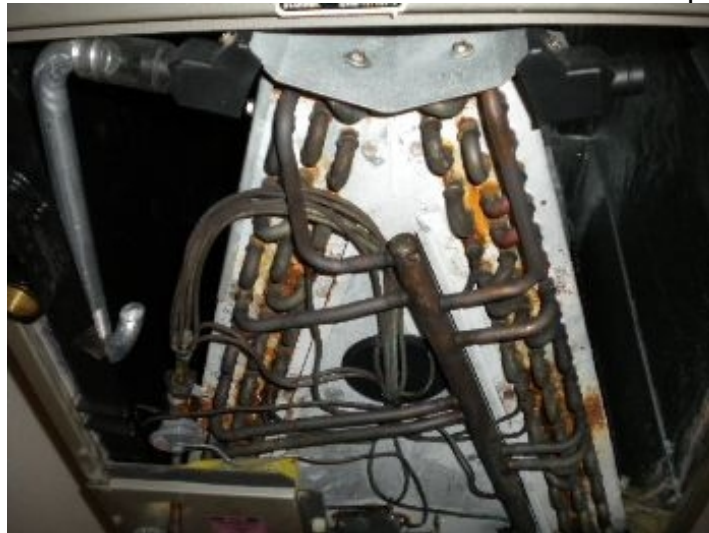
- There is discoloration of coils due to the presence of defective drywall (Chinese drywall).
- Units did not operate properly at time of inspection.
- Estimated cost: See compressor section

There is discoloration of coils due to the presence of defective drywall (Chinese drywall).

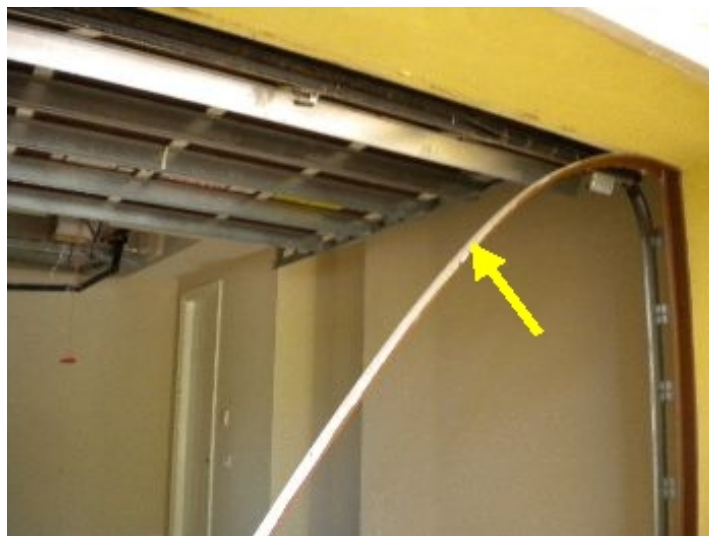
- No functional issues at time of inspection
- **Garage Vehicle door trim is damaged.**
- **Estimated cost:\$75**

Garage Vehicle door trim is damaged.

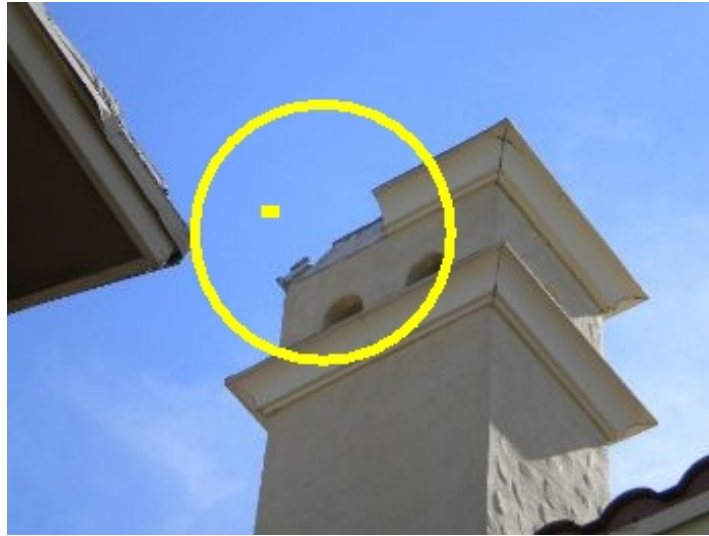
Damage

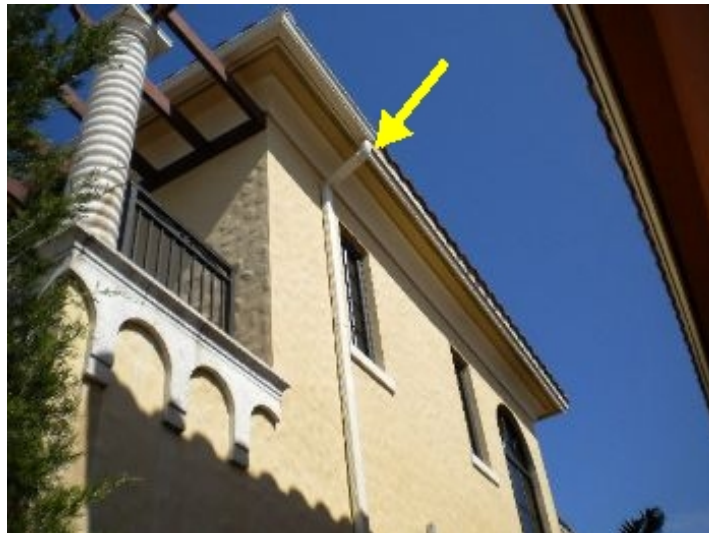
Partial gutters - Full installation recommended to keep water away from structure. Water can weaken the foundation.

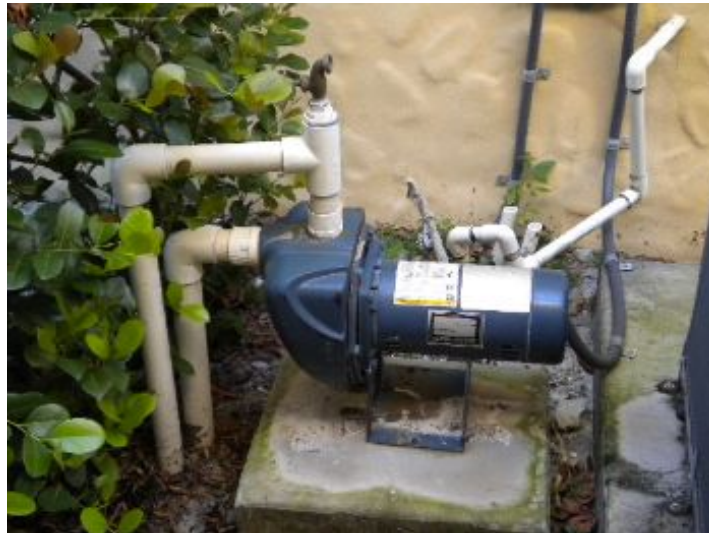
- The system did not operate when tested. Recommend licensed contractor to evaluate.
- Water supplied from lake
- 4 Zone
- Estimated cost:
- \$300-\$400

The system did not operate when tested. Recommend licensed contractor to evaluate.

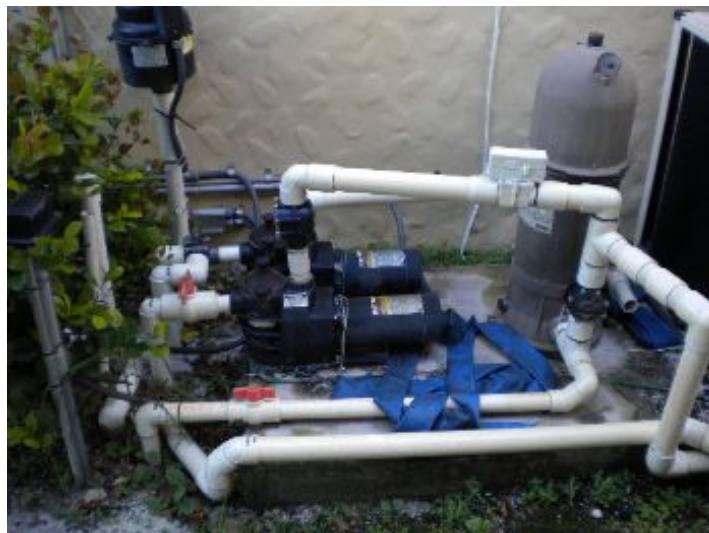
Observations:
 • did not operate n/a
 • recommend pool contractor to evaluate

did not operate

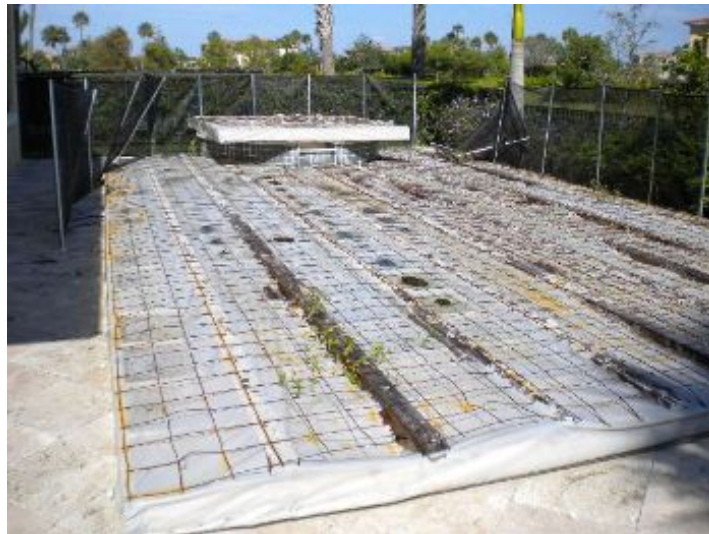
- Structure was crated and not visible at time of inspection. Pool will need to be drained, acid washed and restarted by a licensed pool contractor.
- Estimated cost:
- \$1500-\$2500

Structure was crated and not visible at time of inspection. Pool will need to be drained, acid washed and restarted by a licensed pool contractor.

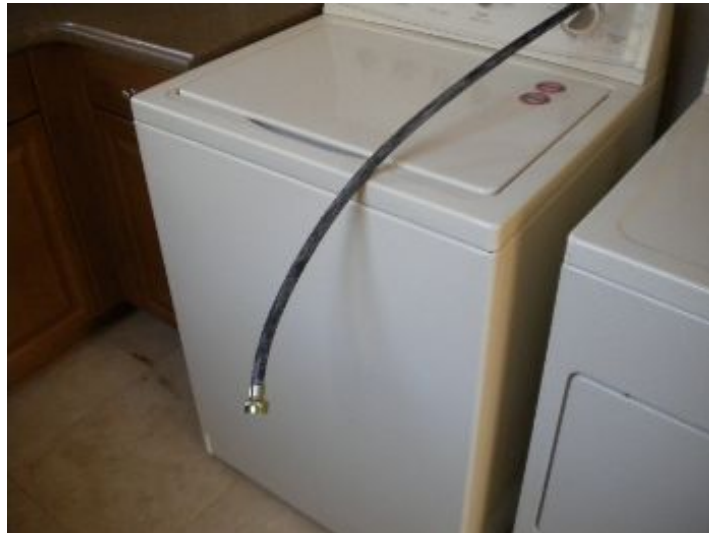
Observations:
 • Unit was not hooked up to water supply at time of inspection.

Unit was not hooked up to water supply at time of inspection.

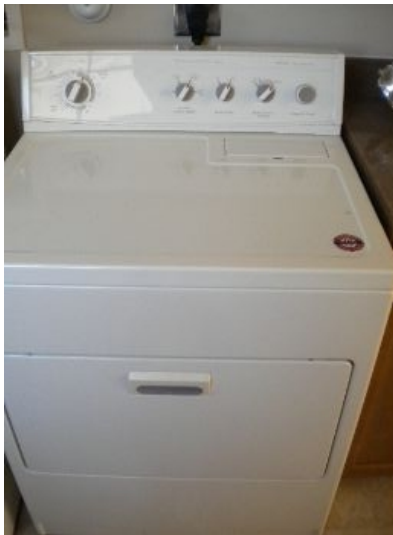
- Dryer vent not connected
- Estimated cost:\$75

Dryer vent not connected
